Manhole Inspection Summary

Manhole # S39K__010MH

Insp Date: **12/30/08 9:30 AM**

Location Address: **fleet st**

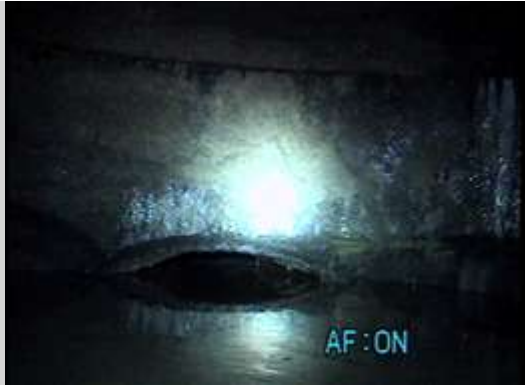
12 O'Clock Outflow

66 in. Circular Gravity Sewer
Pipe Out @ 12 O'Clock

Pipe Material: **Concrete** ☐ Pipe Lined

Invert Depth: **19.00** (ft.) Flow Characteristics: **Slow**

Deposits: ☒ None ☐ Mud ☐ Sludge ☐ Debris ☐ Grease

Infiltration: **None** Pipe Seal Cond: **Unknown**

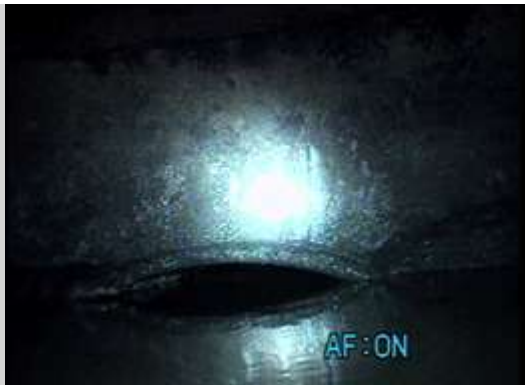
4 O'Clock Inflow

66 in. Circular Gravity Sewer
Pipe In @ 4 O'Clock

Pipe Material: **Concrete** ☐ Pipe Lined

Infiltration: **None** Pipe Seal Cond: **Unknown**
